Cavity Walls

Advantages and disadvantages of Cavity Walls

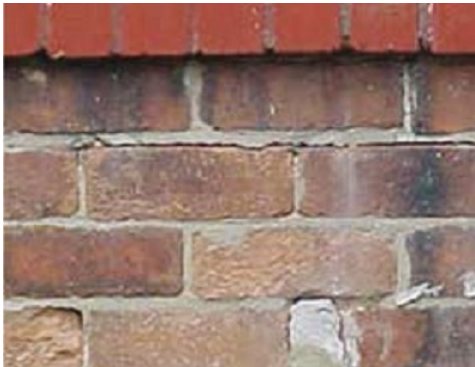
Fig4—Horizontal cracking in mortar joint

The main cause of deterioration of cavity walls is wall tie corrosion. If inadequately protected, the steel ties will rust due to the presence of air and water in the cavity. The constituents of mortar droppings can accelerate this process. When steel corrodes it will expand up to ten times the thickness of the parent metal. The ends of the wall ties embedded in the outer leaf will lift the bricks above, causing a horizontal crack to appear in the mortar joint (see Fig 4).
