REPORT
ON THE
CONSTRUCTION AND CONDITION
OF THE PROPERTY
known as
'#####'

SN2 ###

Date of inspection:

17th September 2020

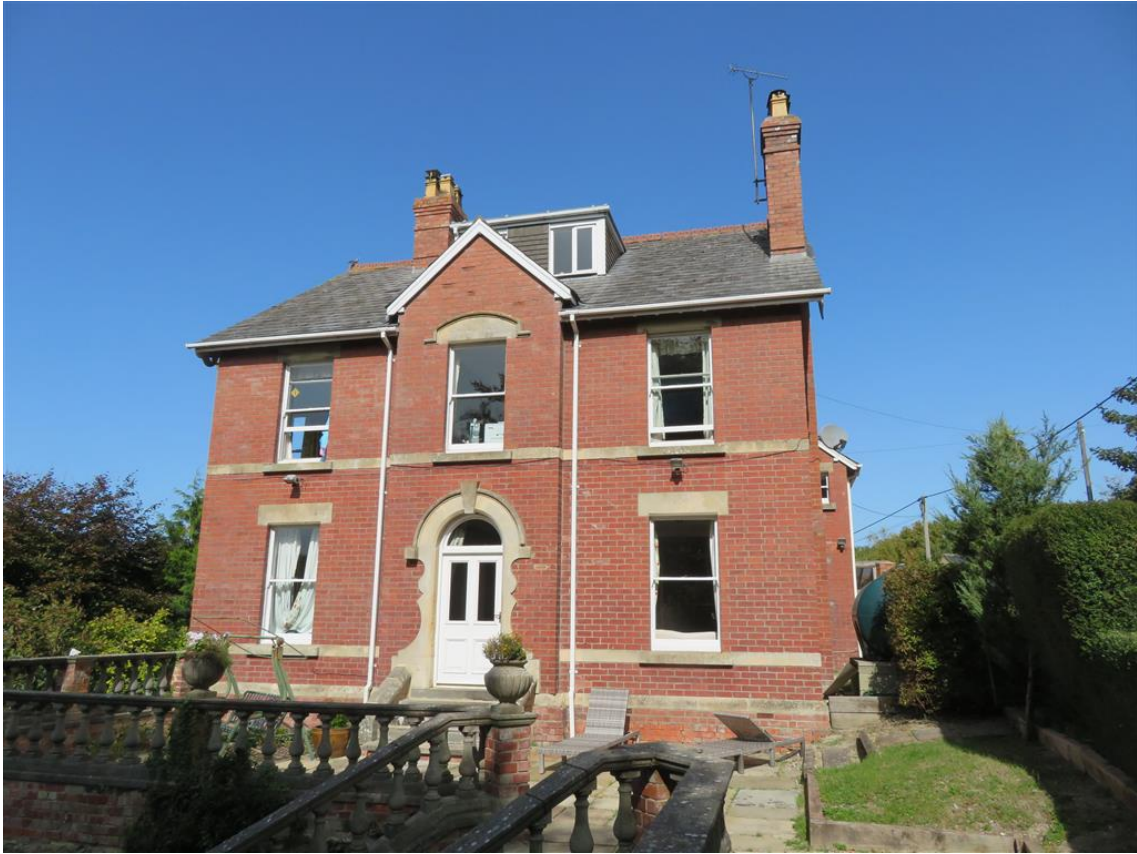
Front (south) elevation

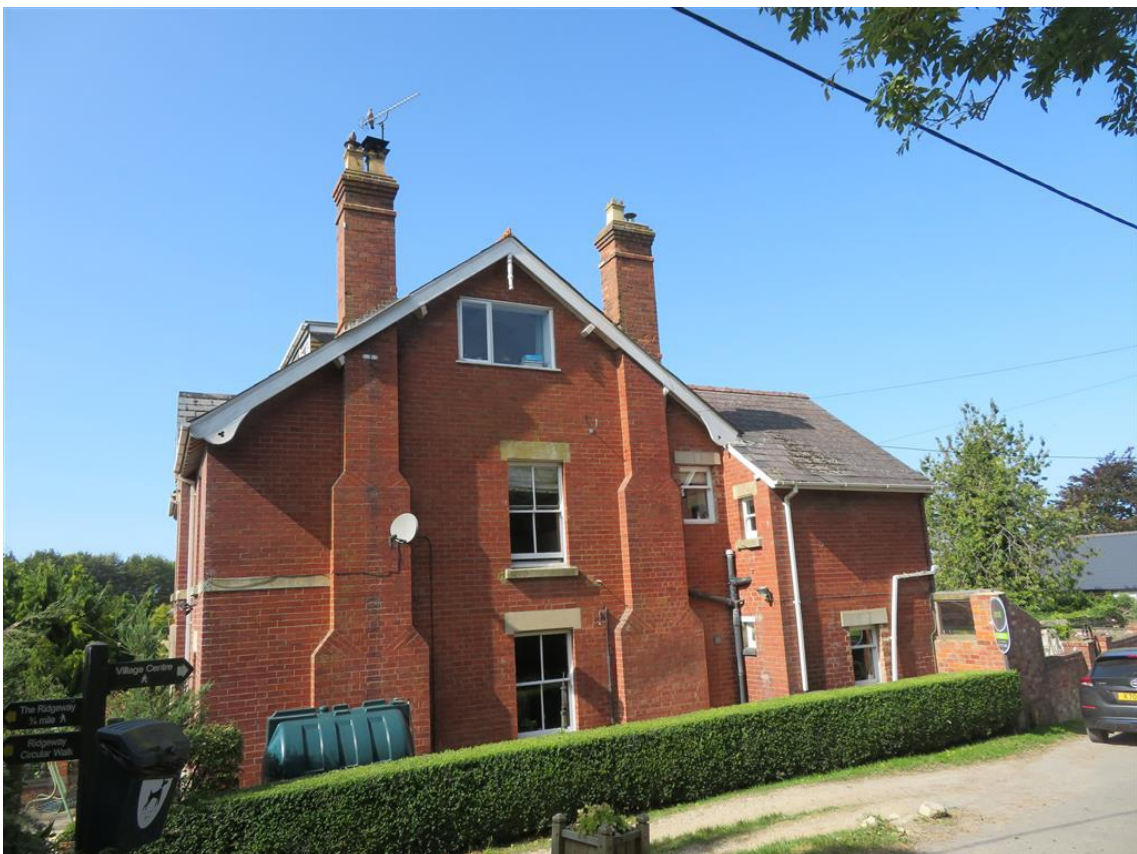
Side (east) elevation

Three slates on the east facing roof slope are supported on lead clips, which are known as 'tingles'. A small number of tingles are also visible on the north facing roof slope. This indicates that the fixings for these slates have failed, causing the slates to slip. It is likely that other fixings will fail from time to time.
